Water Conveyance Facility Safety Management Plan TEMPLATE

STRAWBERRY HIGH LINE CANAL COMPANY

Water Conveyance Facility Safety Management Plan

January 2011

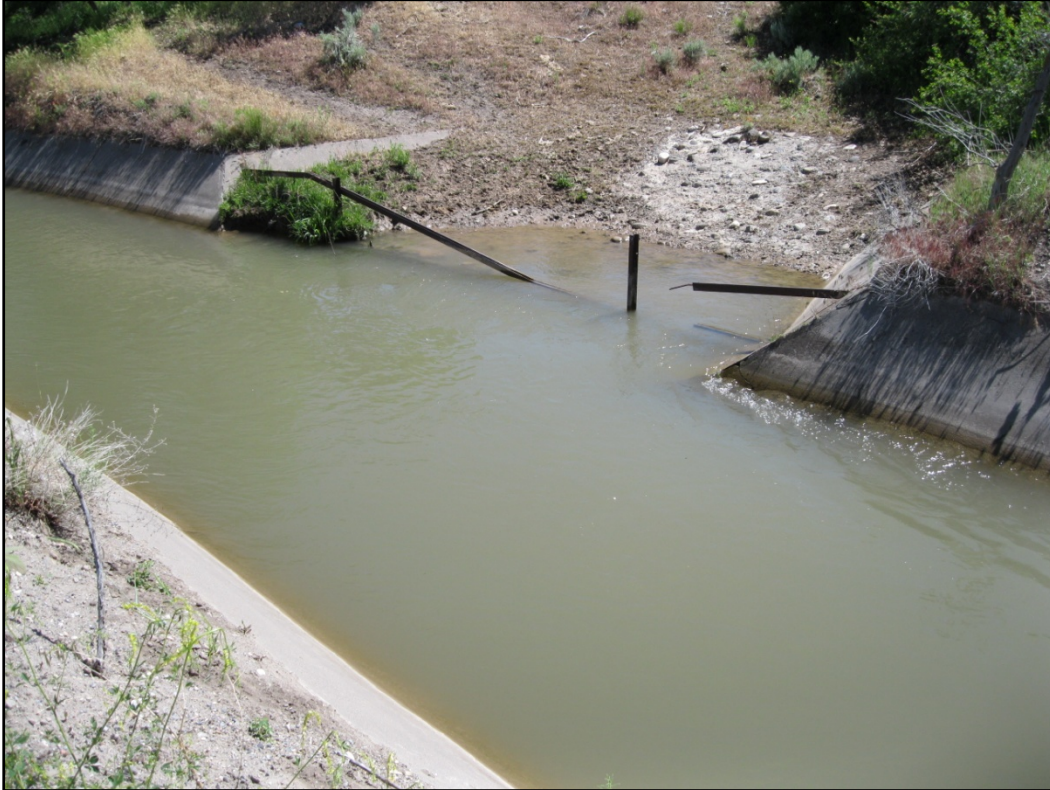
Animal watering point on the uphill side of the Strawberry High Line Canal.

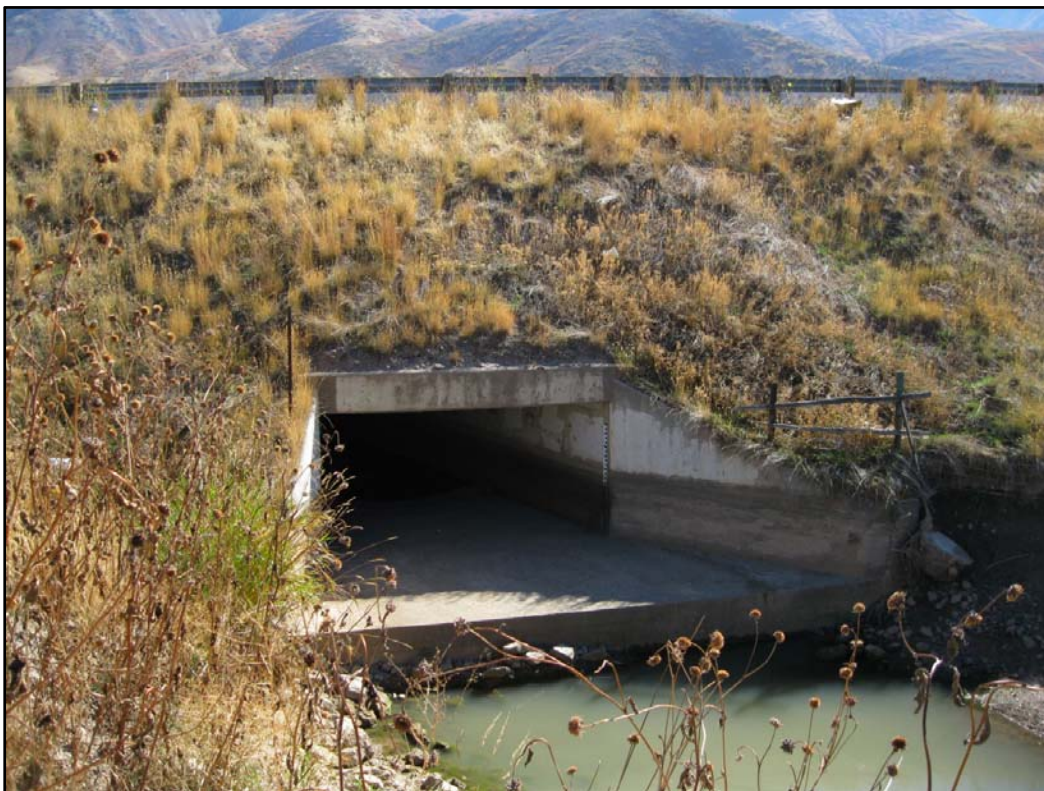
Even though it is not directly related to slope stability, one facility deficiency was documented using the *Slope Stability and Land Use Inspection Sheet*, and is identified as Finding 2010-08 in Appendix A. The problem relates to the floor of the canal tunnel under Interstate 15, which was constructed at too high of an elevation and thus causes the water level in the canal to rise above the designed freeboard. Although the tunnel is in a low risk location, the effects are propagated upstream into Reach 5, which is a potential risk location. During peak flow periods the water level at the end of Reach 5 rises above the concrete liner. A 24-inch storm water entry pipe, which is located just upstream from the tunnel, further increases the risk of failure. Section 3.4.3 details what the SHLCC will do to address this issue.

The elevation of the tunnel floor is approximately 18 inches above the downstream canal.

As noted in Section 2.4, the tunnel under Interstate 15 creates problems that propagate upstream into the potential risk location of Reach 5. During normal operation, the SHLCC monitors this situation frequently to make sure it does not cause a serious threat, but would prefer a permanent solution. The SHLCC will discuss this issue with the Utah Department of Transportation (UDOT) and request that modifications be made to the structure so that it can function properly in relation to the upstream canal.

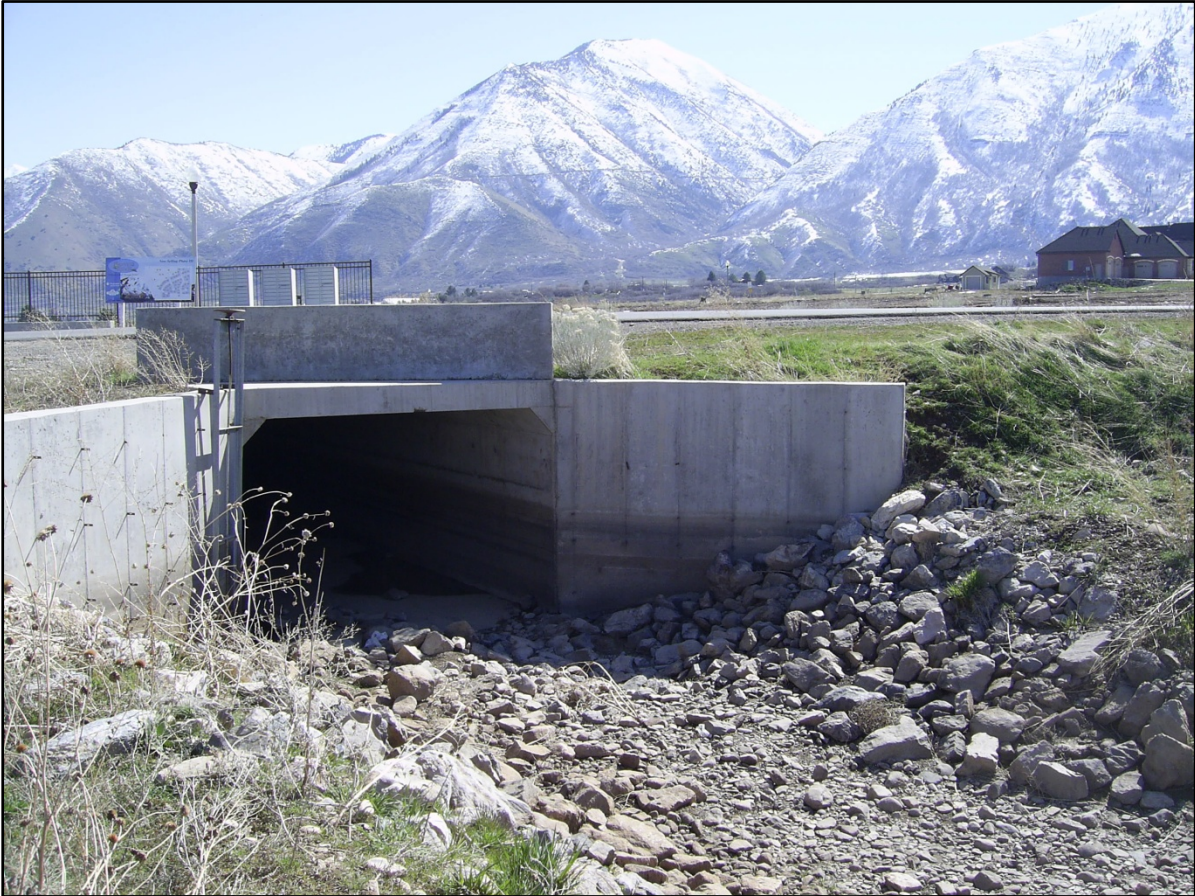
County roads that are built without a curb and gutter allow storm water to enter the canal.

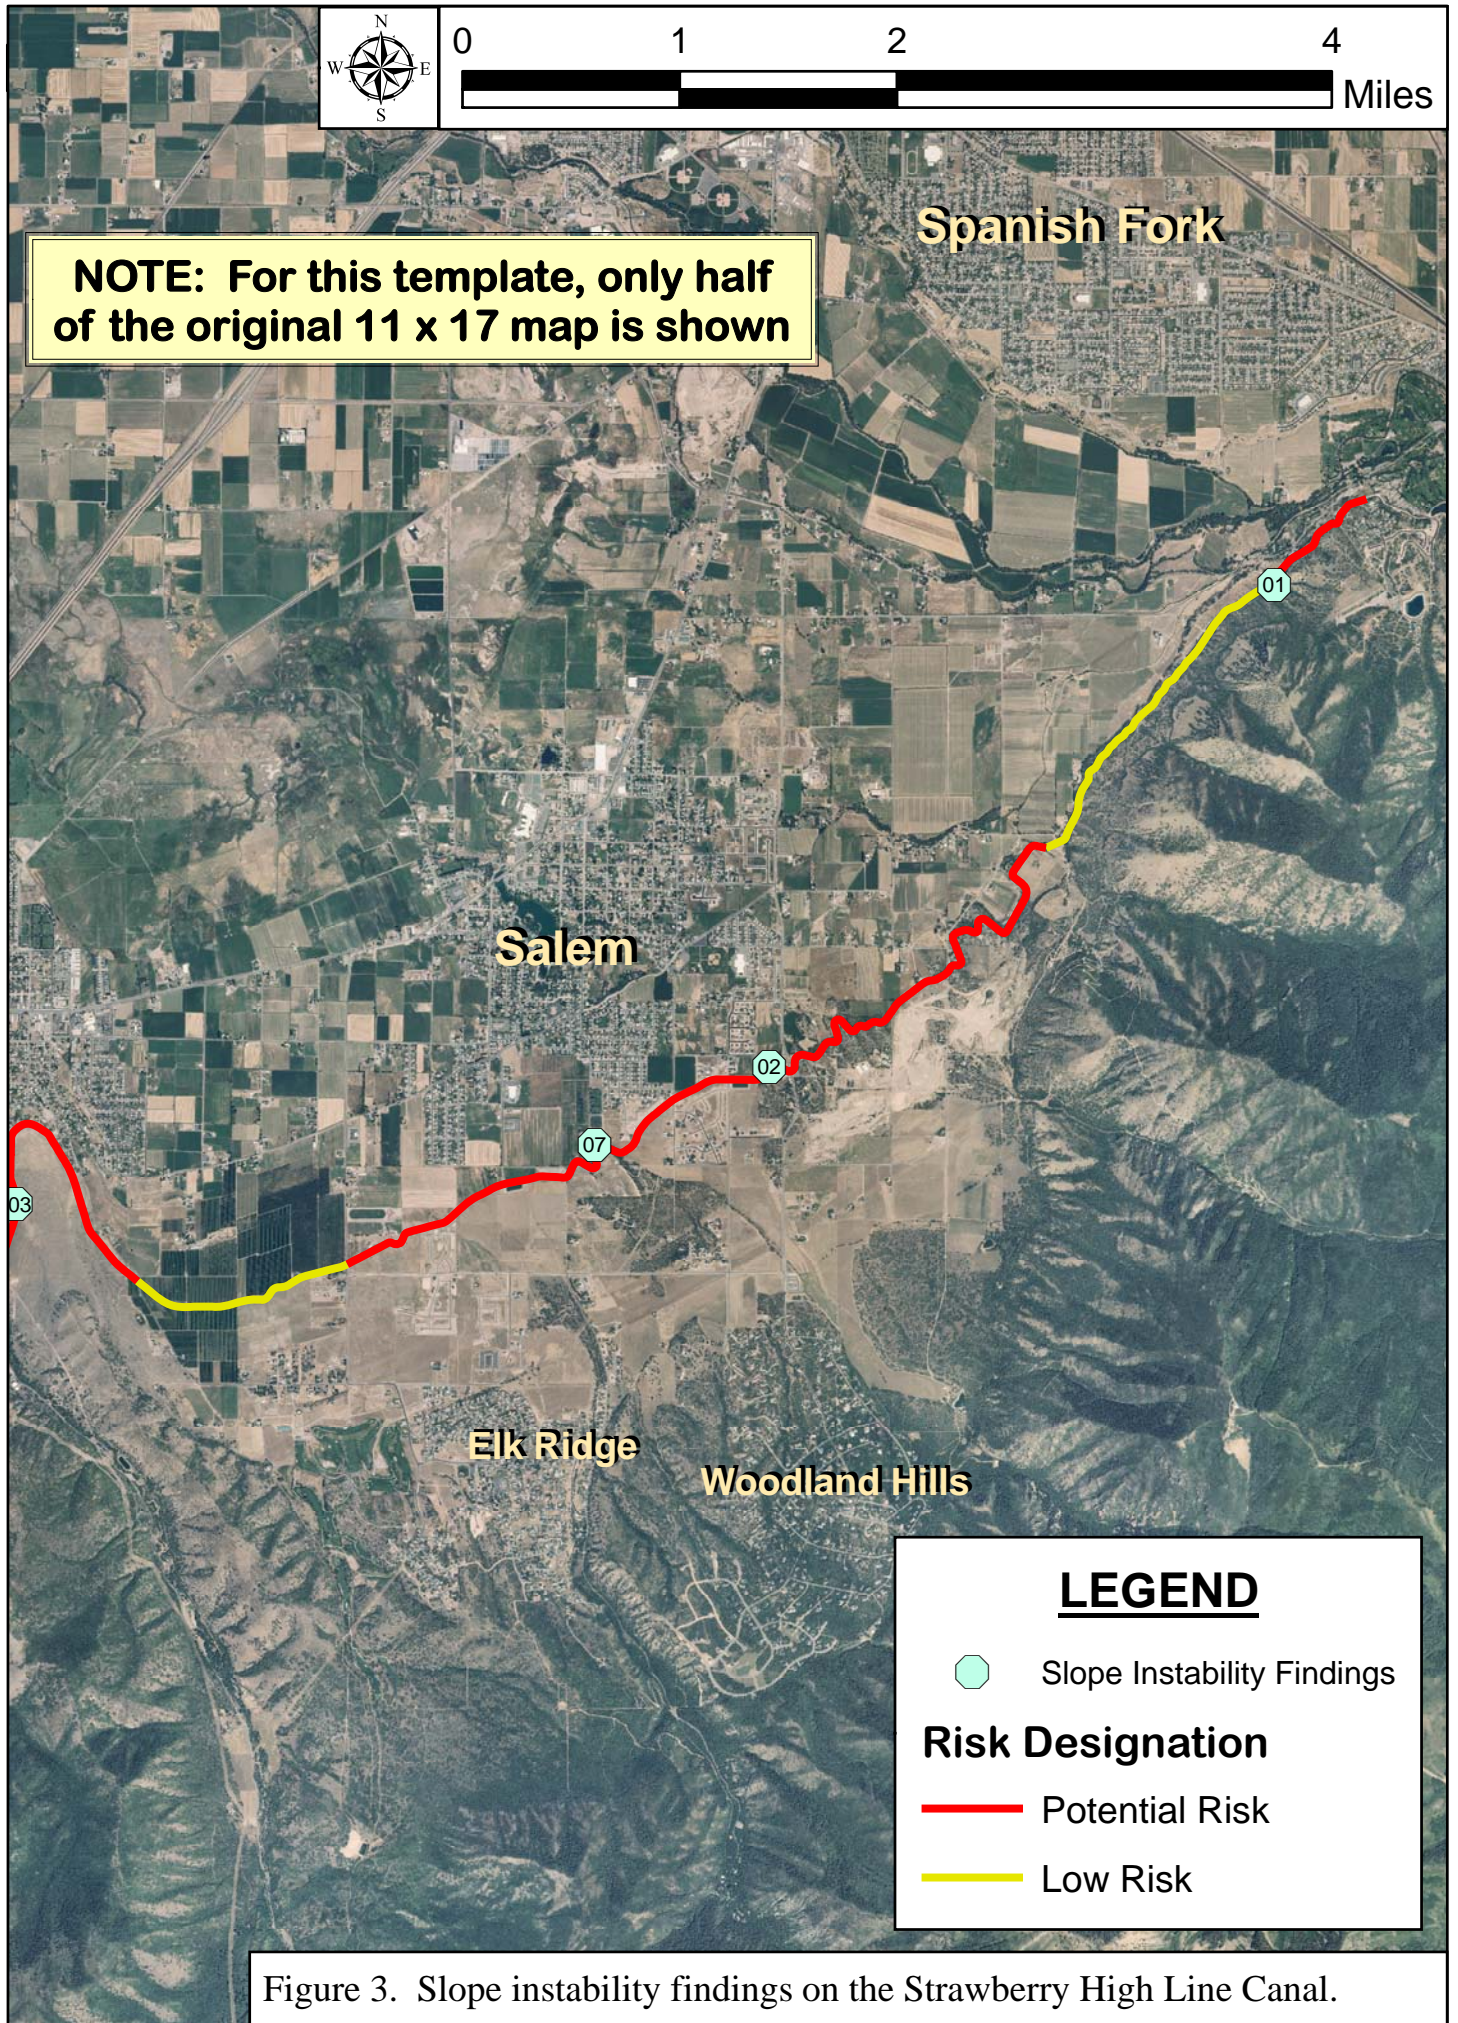
Figure 3. Slope instability findings on the Strawberry High Line Canal.

On October 20, 2010, a slope instability evaluation was performed for the potential risk locations, using the *Slope Stability and Land Use Inspection Sheet*, a copy of which is found in Appendix E. Seven areas of concern were documented as findings and these are summarized in Table 4. Appendix A contains the completed inspection sheets for each finding. Figure 3 shows the geographic location of the seven findings.

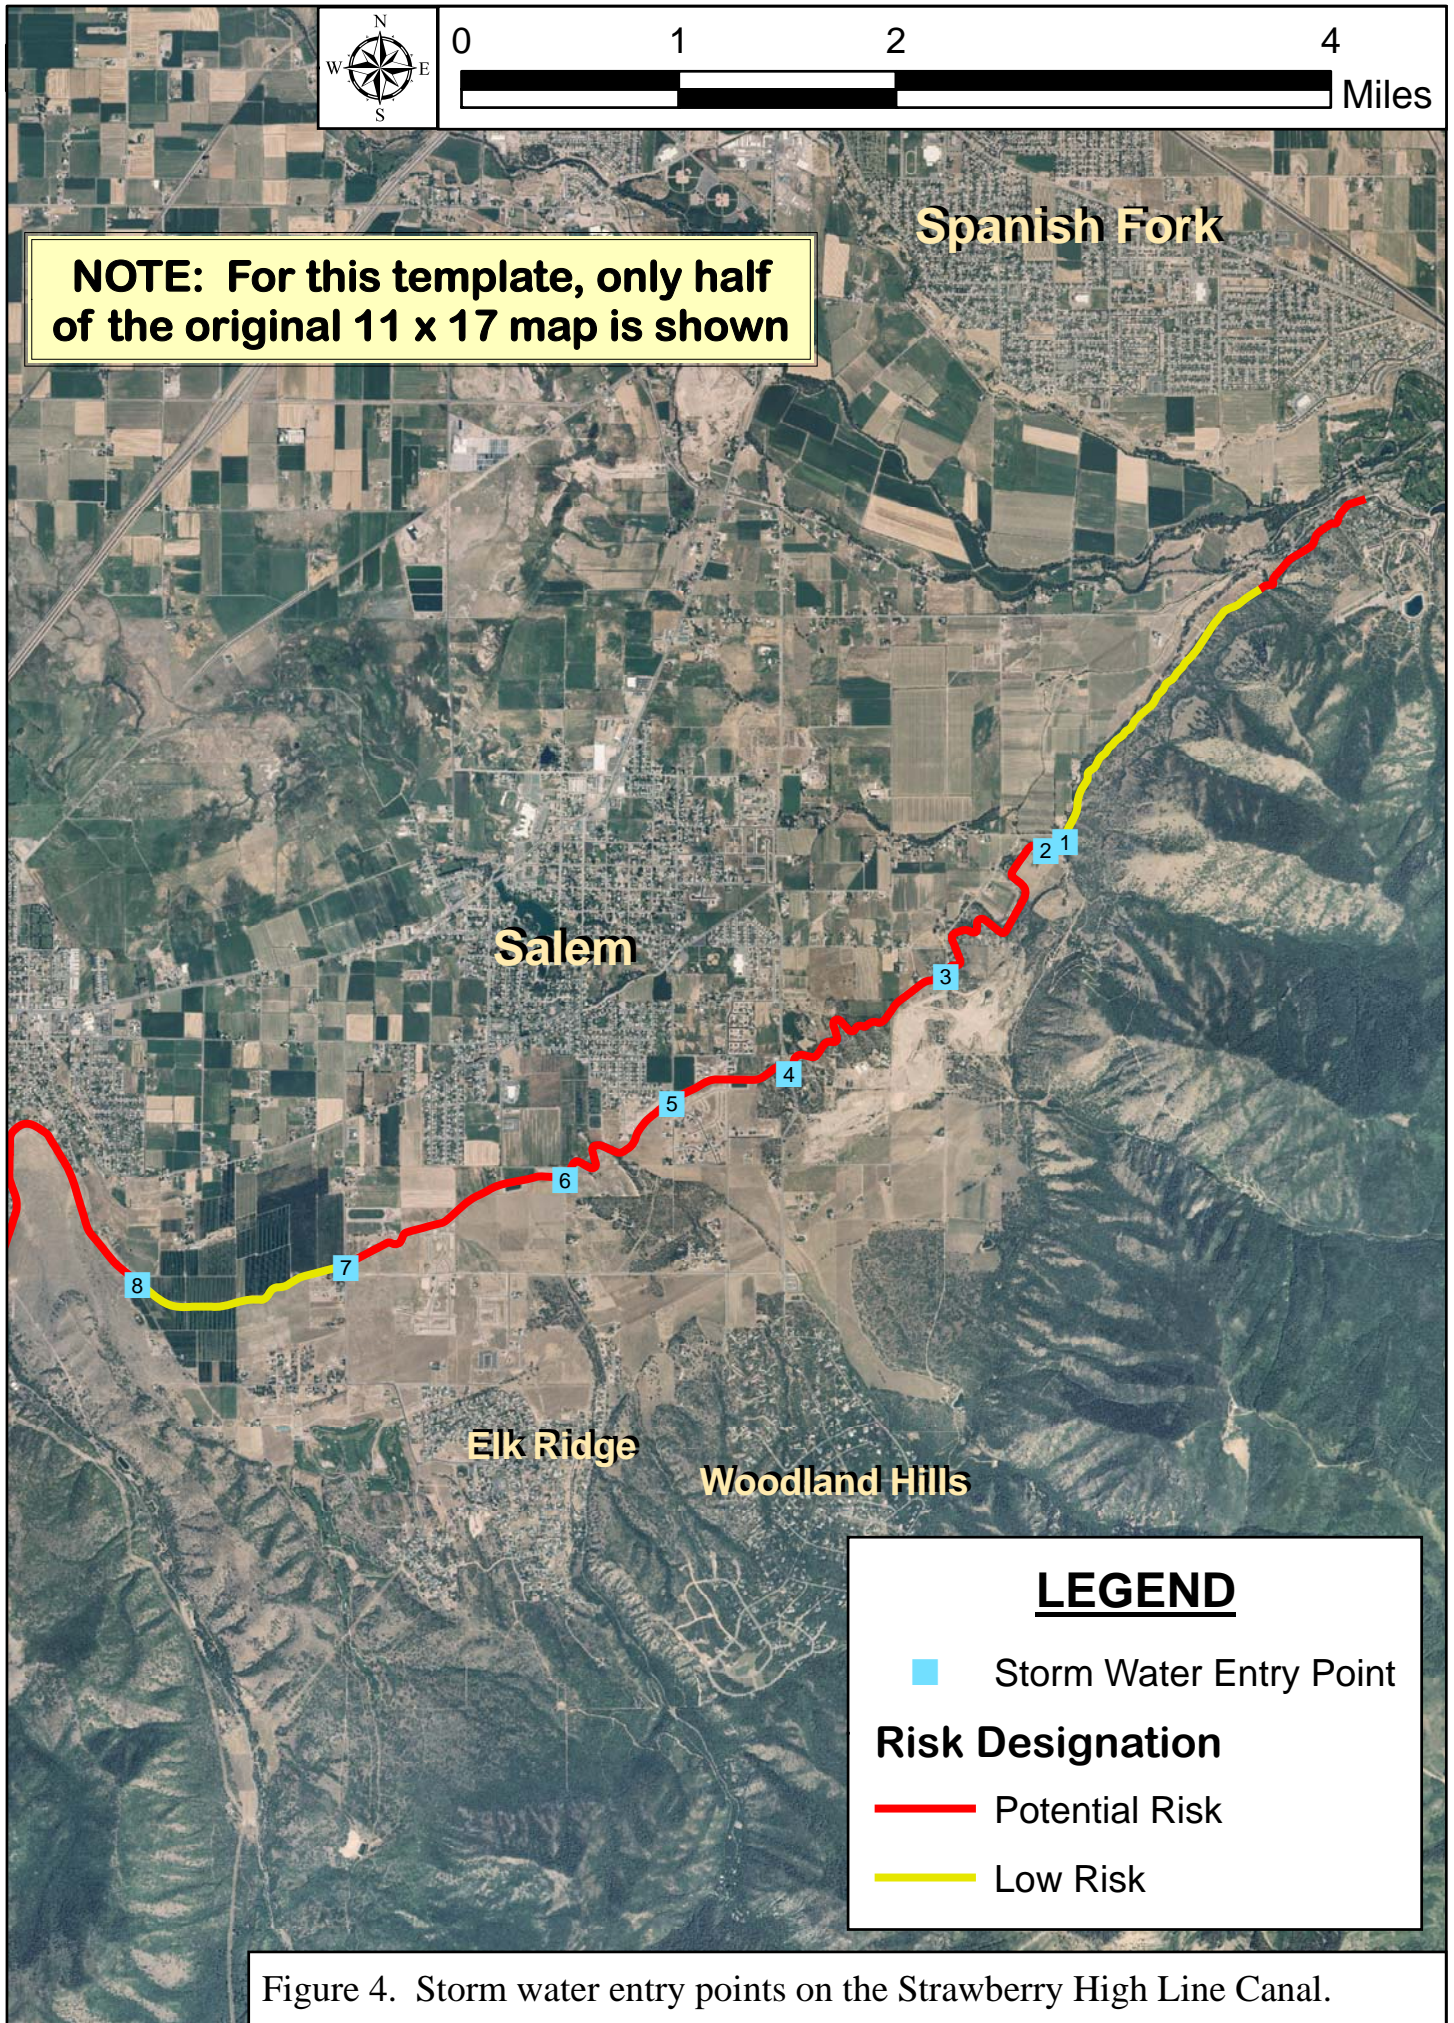
Figure 4. Storm water entry points on the Strawberry High Line Canal.

Eleven locations where storm water enters the canal have been documented, and a plan will be implemented to eliminate all of these storm water entry points.

As noted in Section 2.3, storm water enters the canal in eleven other locations. Ten of these are at road crossings where surface water flows into the canal. The remaining entry point is a pipe that collects and discharges runoff from a commercial area in Santaquin and from a short section of Interstate 15.

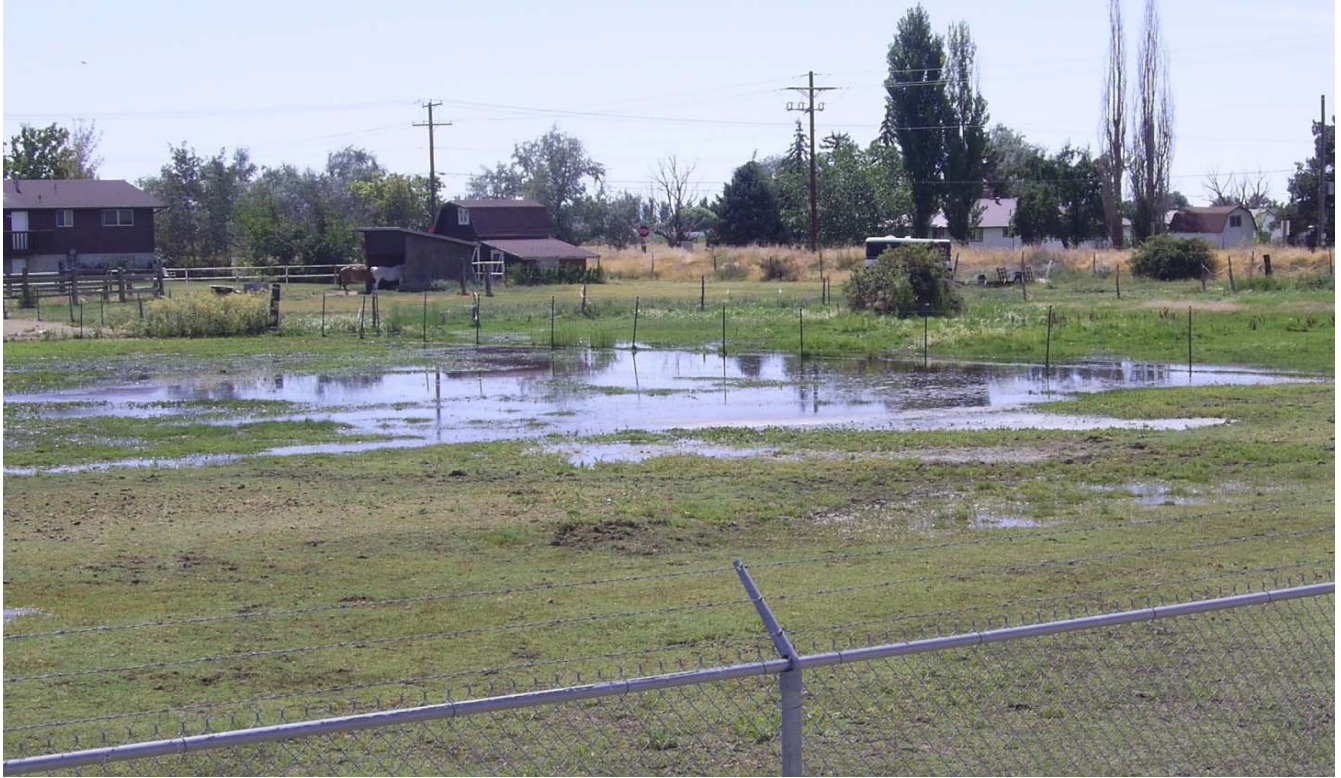
FINDING NUMBER 2010-25

Date of Inspection <i>December 25, 2010</i>	Finding No. <i>2010-25</i>	Noticeable Items of Concern (check all that apply)
Location / Canal Reach / Length <i>1,000 feet downstream from the head of the canal (N41°34.413', W110°06.696').</i>		<p style="text-align: center;">LAND MOVEMENT</p> <input type="checkbox"/> Historical slide area; existing slope failure area <input type="checkbox"/> Settlement; subsidence; slumping; bulging <input type="checkbox"/> Cracks; openings; depressions; sinkholes <input type="checkbox"/> Lateral movement; displacement; fault movement <input type="checkbox"/> Dead or dying vegetation; tilted trees <input type="checkbox"/> Surface erosion; debris accumulation <input type="checkbox"/> Other _____
Observations <i>There is a significant amount of standing water in a field on the downhill side of the canal. The canal in this section has a concrete liner. The part of the liner that is visible above the water level is in very good condition; there are no cracks or other damage, and the joint seals all appear to be intact.</i>		<p style="text-align: center;">WATER CONTENT</p> <input checked="" type="checkbox"/> Spring; seepage; flowing water; standing water <input type="checkbox"/> Wet or saturated area; wetland; wetland vegetation <input type="checkbox"/> Intermittent water accumulation; irrigation tail water <input type="checkbox"/> Drainage area; signs of prior water flow <input type="checkbox"/> Other _____

Standing water approximately 150 feet from the canal (pictured from the west side canal road).
